### *Shore ice ride-up and pile-up features*

*Part I: Alaska's Beaufort Sea coast*

# CRREL Report 83-9

Austin Kovacs

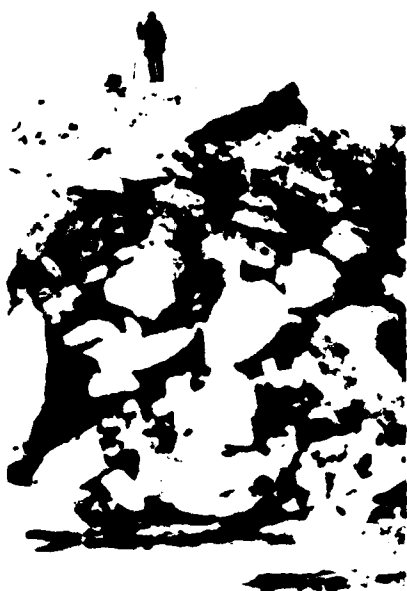
*Figure 4. Eleven-meter-high spring shore ice pile-up, about 1914. (From Stefansson Collection, Baker Library, Dartmouth College.)*

Sea ice pile-up (Fig. 4) and ride-up (Fig. 5) on arctic and subarctic shores are frequent and unpredictable events (Kovacs and Sodhi 1980). These phenomena have pulverized boats, destroyed piers and wharfs, and on occasion crushed houses along with their unlucky inhabitants (Kovacs and Sodhi 1980, Yates 1982, Dekin 1982). Stefansson (1969) stated: "houses which stand one or two hundred yards from the beach are in danger" of onshore ice movement. These events cause concern today about the safety of facilities located along these shores and on man-made islands. Questions arise as to the frequency and severity of these events.

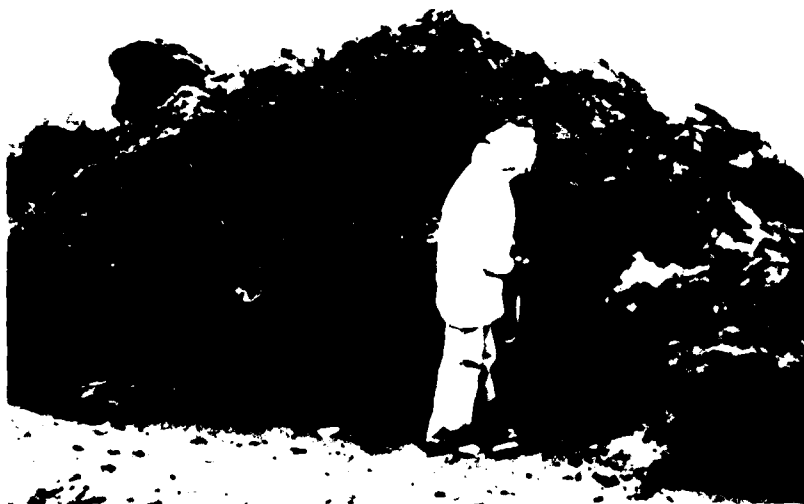
*Figure 8. Ice-pushed silt and peat pile, August 1981. White material in front of observer is sea ice. Arrow points to driftwood incorporated in the pile.*

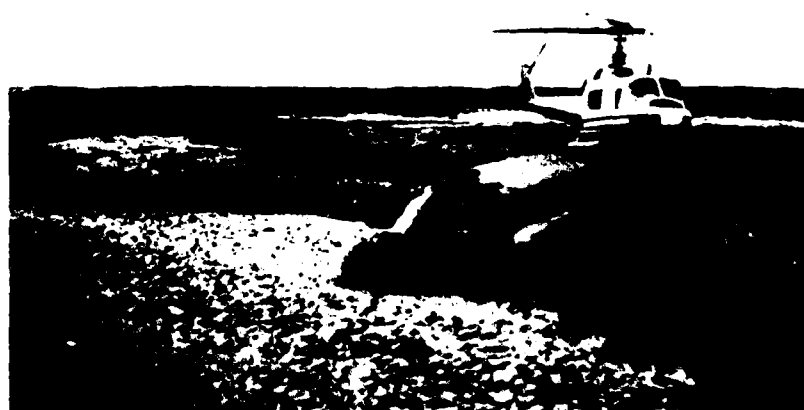
*Figure 9. Aerial (top) and ground (bottom) views of peat slabs displaced by ice ride-up on spit at Drew Pt., August 1981.*

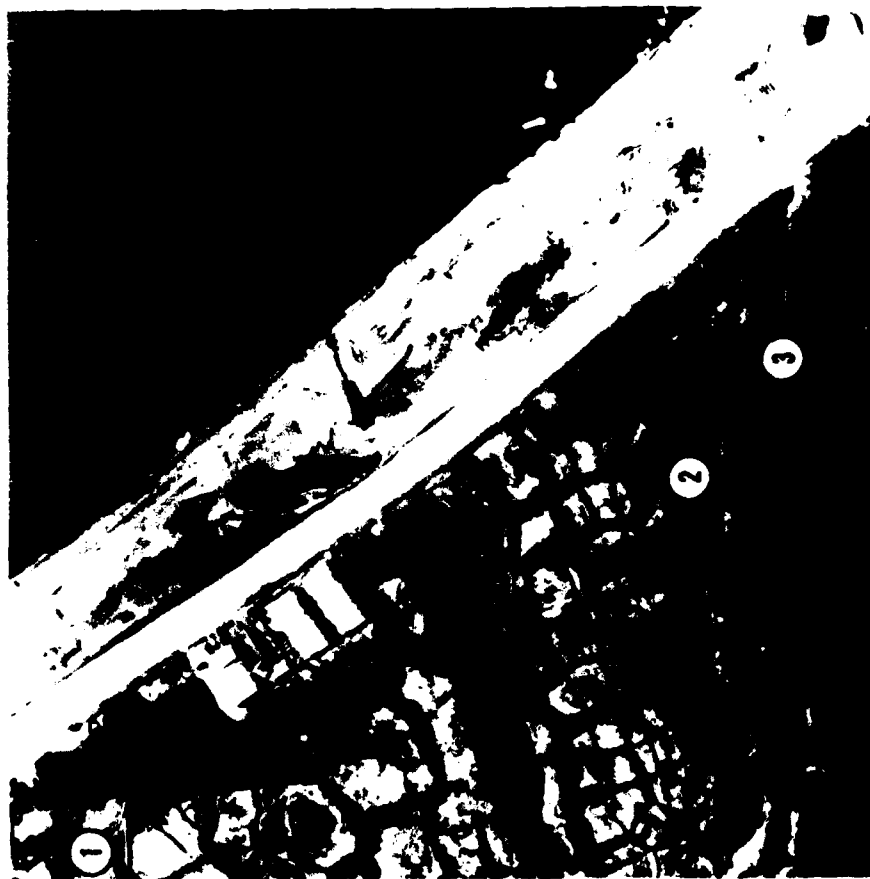
Figure 12. Arrows mark three old ice-scarred tundra relief features near Lonely DEW Line Station. (BLM aerial photo, July 1979.)

Along the beach at Lonely, several old tundra ice scar features not detected on previous reconnaissance flights were discovered (Fig. 12). The ice-pushed tundra

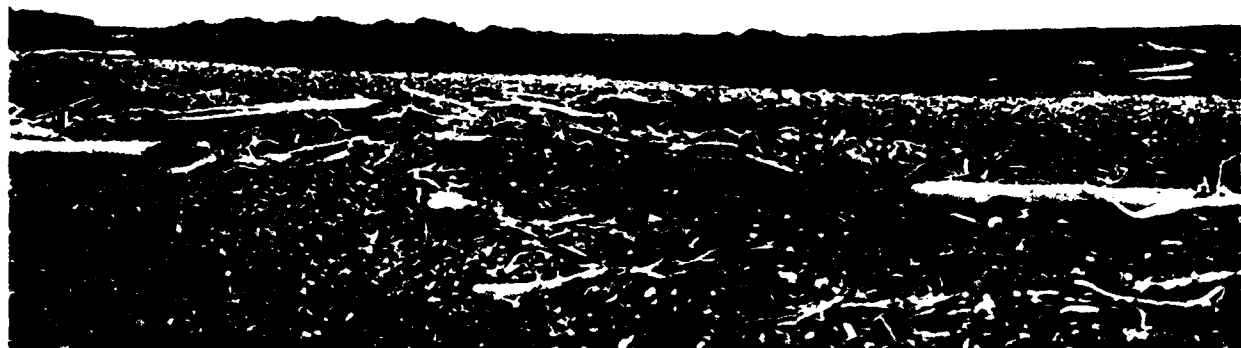
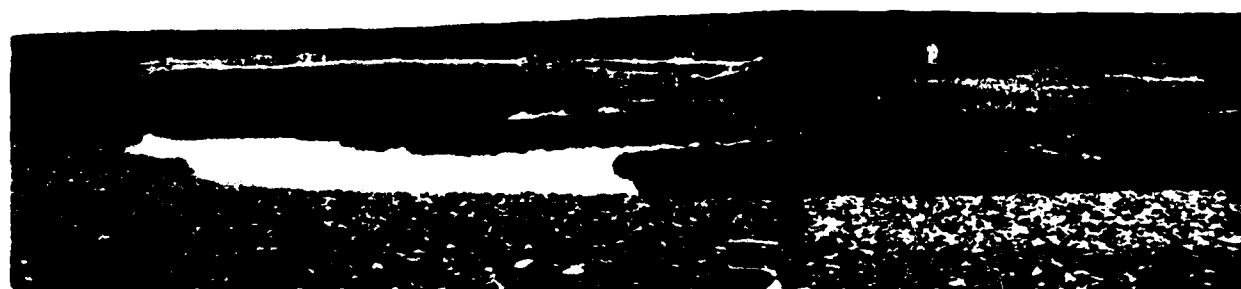
Figure 30. Beach views of ice-scarred tundra, August 1981. Views

Panoramic views of the tundra ice scar shown in Figures 27a and b are shown in Figures 30a and b, respectively. These views show a beach composed of coarse gravel, much driftwood debris, and ice-pushed tundra berms over 1.5 m high. While much of the driftwood is believed to have been carried on shore by high storm seas, we also found wood deeply embedded in the ice-pushed tundra berms, indicating that this wood was incorporated into the soil during ice dozing. The back of the berm behind the person in Figure 30b is shown in Figure 31. Note the apparent difference in elevation of the berm from the two sides.

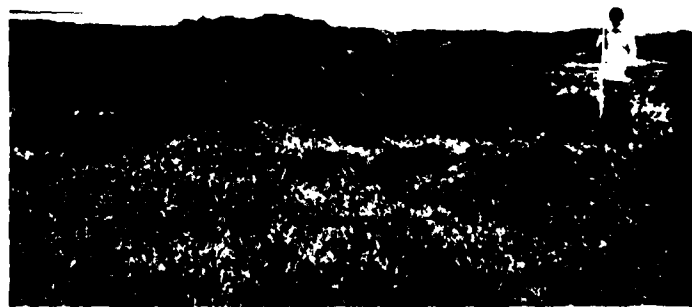
Figure 31. Ice-pushed tundra berm behind person in Figure 30b as seen

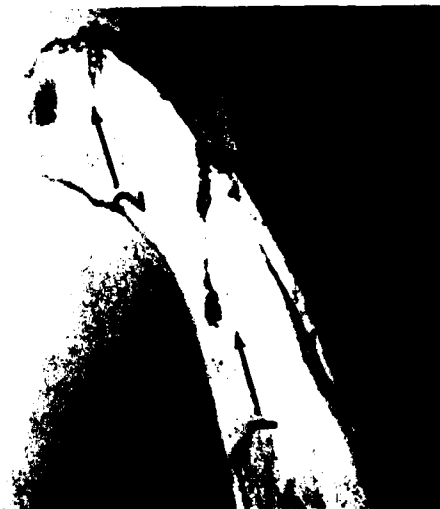
Figure 39. Two major ice scar features on northwest Igalik Island (a) and close-up views (b and c), August 1982. Under the ice-pushed gravel berms much ice existed, which, upon melting, will reduce the height of the berms.

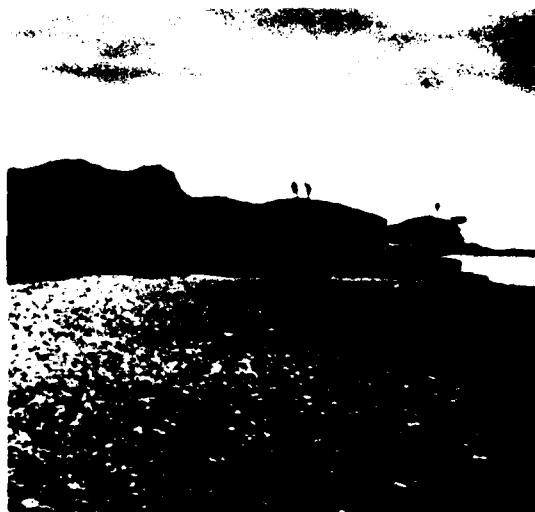
*c. The back (lagoon) side of the largest of the ice pile-up remains. Note that most of the ice is covered with sandy gravel.*

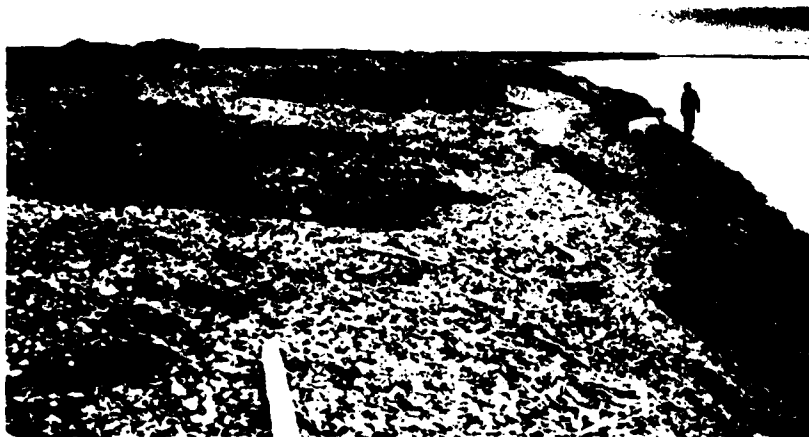
*Figure 50. Ice-pushed gravel piles (a), tundra berms (b) and gravel overlay (c) along the Camden Bay coastal bluffs at position 17, Figure B2, August 1982. Arrow in (b) points to elevation survey site.*

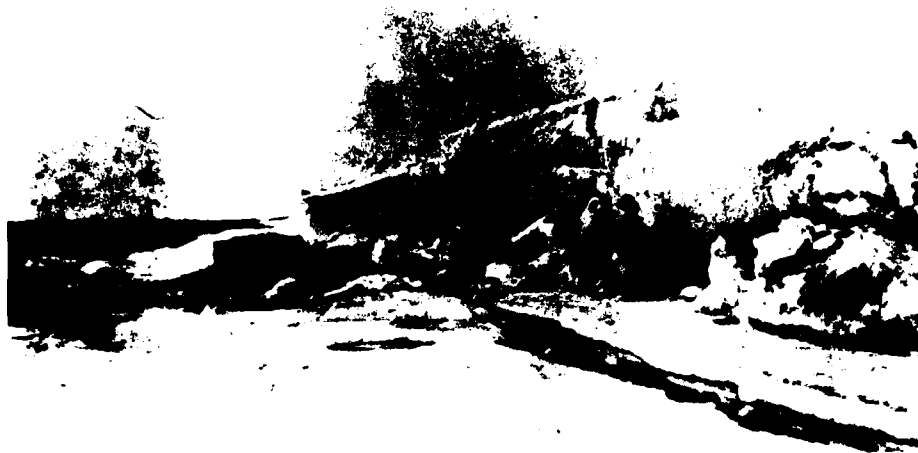
*Figure 57. Ice ride-up on the beach at Clarence Lagoon, Canada (Stefansson Collection, Baker Library, Dartmouth College).*

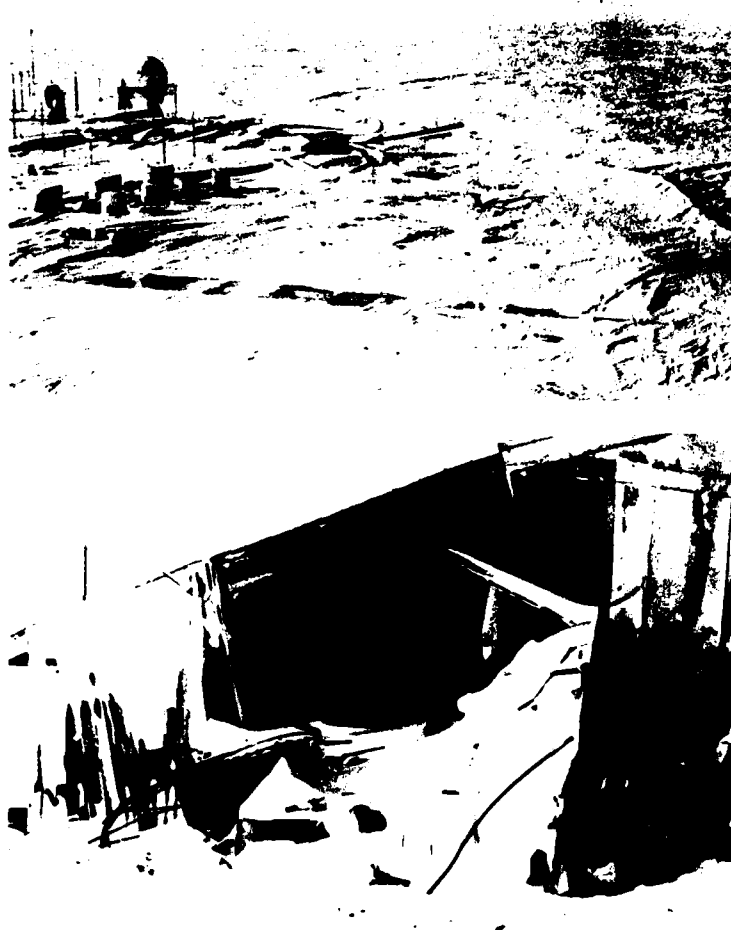
*Figure 58. Bullen Point DEW Line Station, April 1979. Arrow points to garage damaged by ice and also indicates the direction of onshore ice movement.*

At the abandoned Bullen Point DEW Line Station, on the mainland southwest of the Maguire Islands (position 20, Fig. B2), we inspected a garage which had been damaged by shore ice ride-up and pile-up. During the 1973-74 winter, Walter Audi of Kaktovik, Barter Island, observed ice that had moved inland and piled on top of the 4- to 5-m-high garage roof. The 0.30-m-thick ice, which moved from the west-northwest, caved in and entered portions of the steel-framed building shown in Figure 58. We found this building to be located 25 m from the water at an elevation of about 5 to 6 m. (This garage was removed during the 1982 summer cleanup of the site; the main building complex and tanks remain.) The interesting aspect of this ice movement event is that it occurred in a relatively sheltered location which is not only inside the barrier islands but also protected in part by the Bullen Point spit.

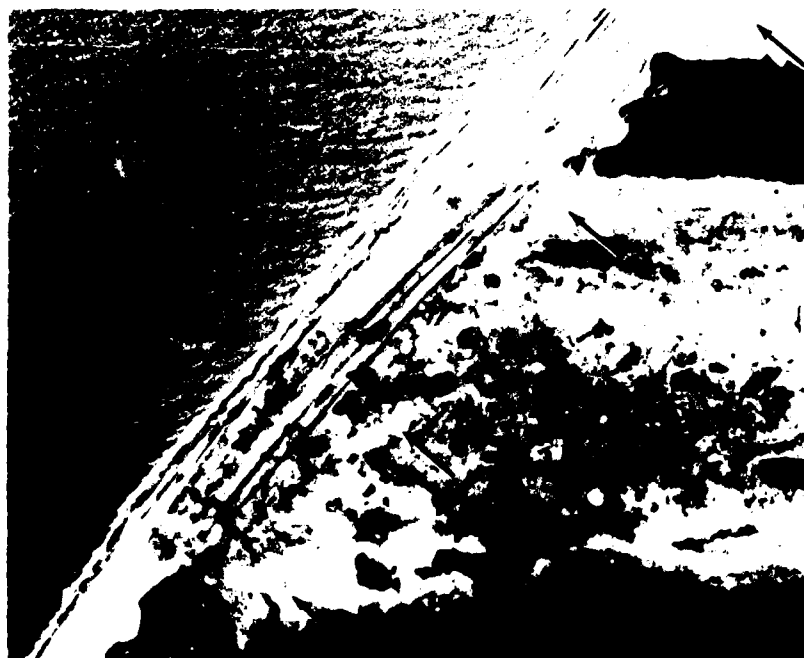
*Figure 63. Recent ice-push gravel ridge formations along Pitt Point, July 1978.*

Coastal erosion since 1949 has removed most of these ice thrust features but newer ones can be observed on recent aerial imagery. For example, in a 1978 aerial photo of Pitt Point, ice-pushed gravel ridges can be observed which extended along much of the coast. These features, shown in Figure 63, are typically 45 to 50 m in from the sea, but on occasion extend 10 to 20 m further inland. In addition, 1981

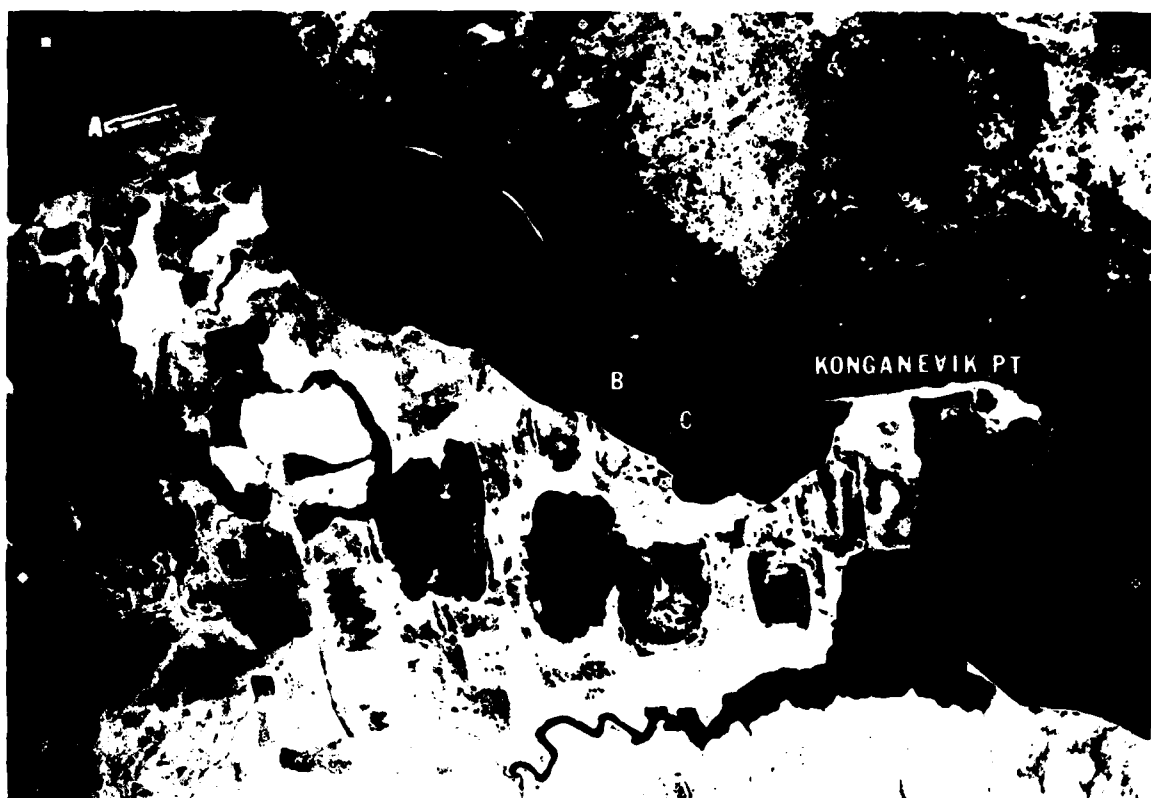
*Figure A1. July 1979 aerial photo of the Beaufort Sea coast near Konganevik Pt. Position A is a lake which is now drained. Position B is the site of a boulder rampart. Position C is the location of a crescent-shaped boulder barricade.*

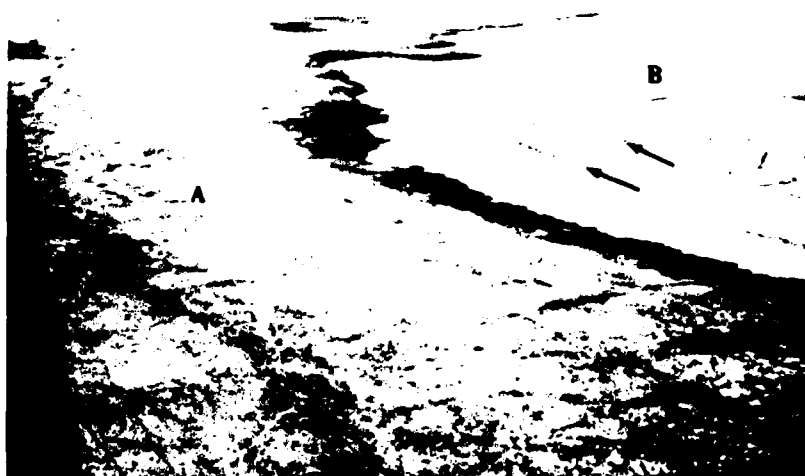
*Figure A2. Drained lake, August 1982. Old drained lake bottom (A) is shown littered with boulders. Recently drained lake bed (B) is presently a mud flat. Arrows point to two rows of boulders.*

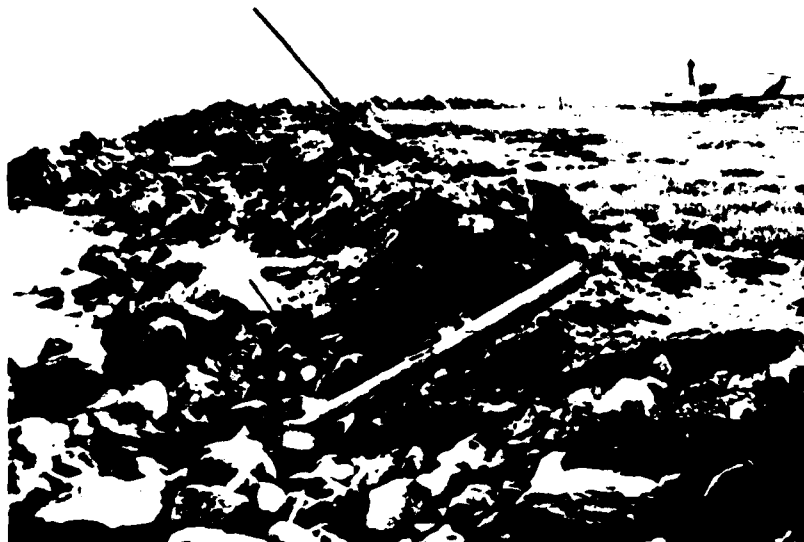
*Figure A4. Configuration of boulder barricade in August 1982. Arrow in top photo points to tundra sod on top of boulder. Arrows in bottom photo point to partly exposed boulders in the tundra.*

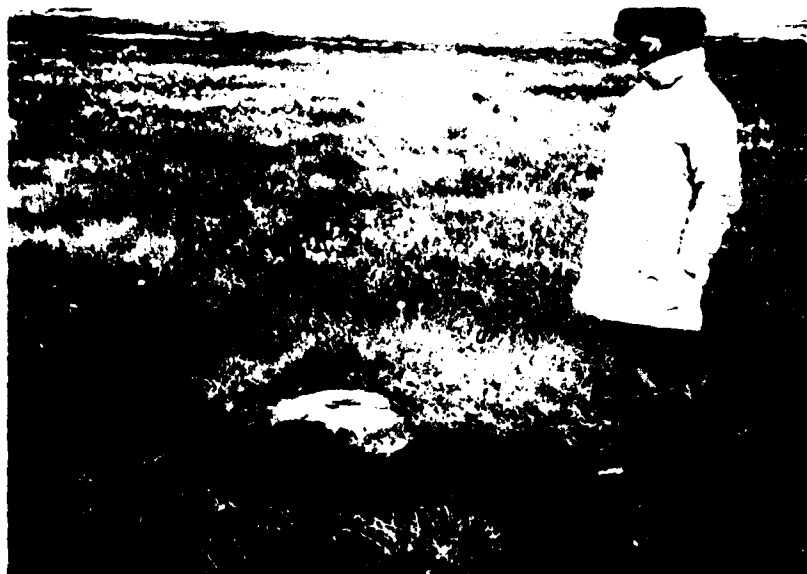
*Figure A5. Boulders on the tundra several tens of meters south of the boulder barricade, August 1981. Note lichen growth on the boulder in bottom photo.*

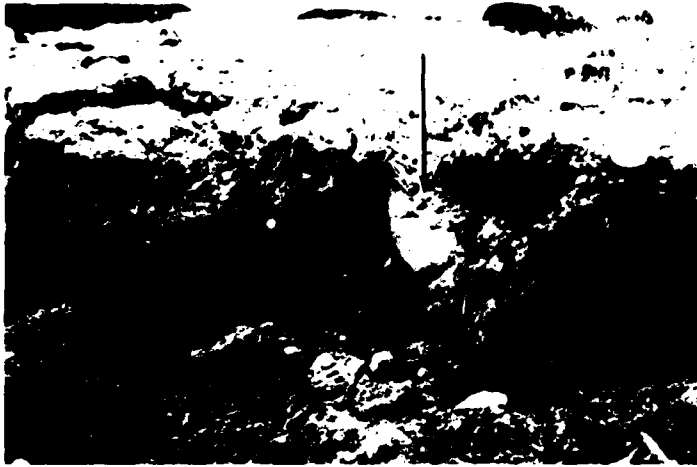
*Figure A6. Eroding bluff at boulder barricade site showing variation in rock debris, August 1981. Boulder at arrow is about 0.35 m wide. Note rocks on tundra surface which were carried there by ice ride-up. Also scattered on the tundra surface are lumps of sod (dark material).*

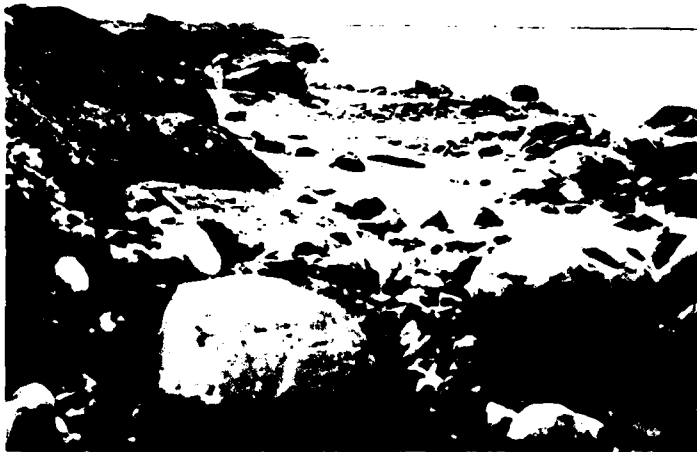
*Figure A7. Bluff to the west of main boulder rampart. Here only a few boulders have been pushed onto the edge of the bluff. Note the scarred boulder in the foreground.*

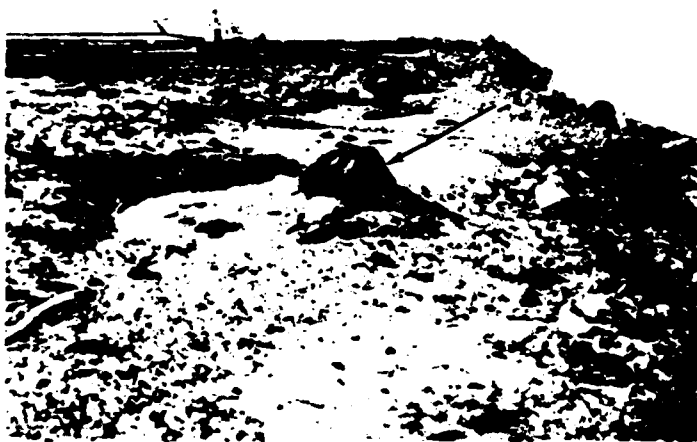
*Figure A8. View looking west to boulder rampart from low-lying beach area, August 1982. Boulder described by Barnes (1982) is at arrow and no longer has a gouge leading up to it from the sea as a result of wave run-up erosion processes.*

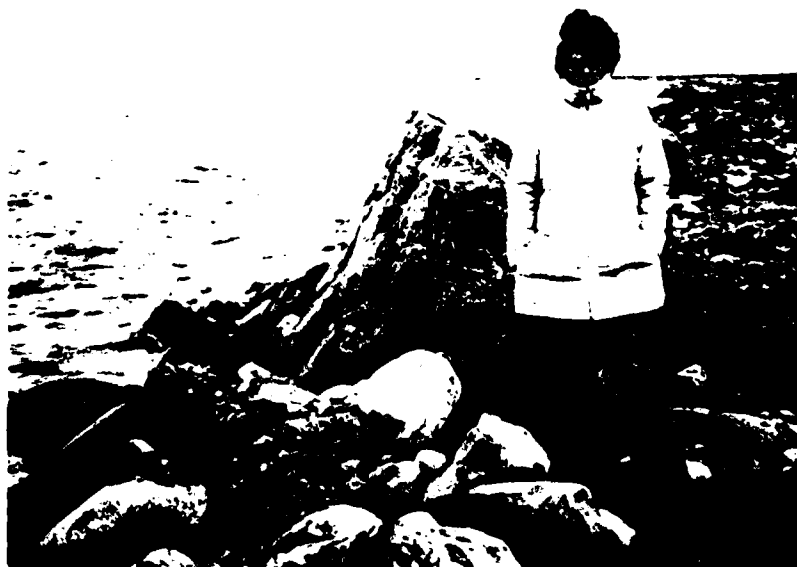
*a. April 1980.*

*b. August 1981. Large boulder is about 1½ m long.*

*Figure A9. Sand and gravel deposits on boulders.*

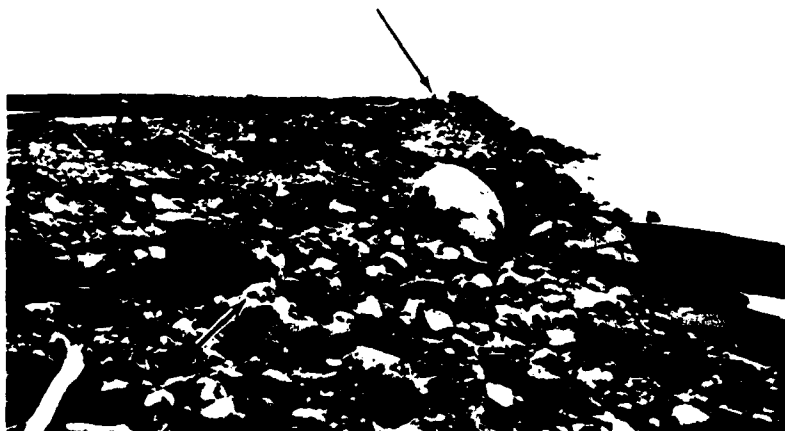
*Figure A11. View of boulder rampart from the east taken in summer 1979. (Photo courtesy P. Barnes.)*

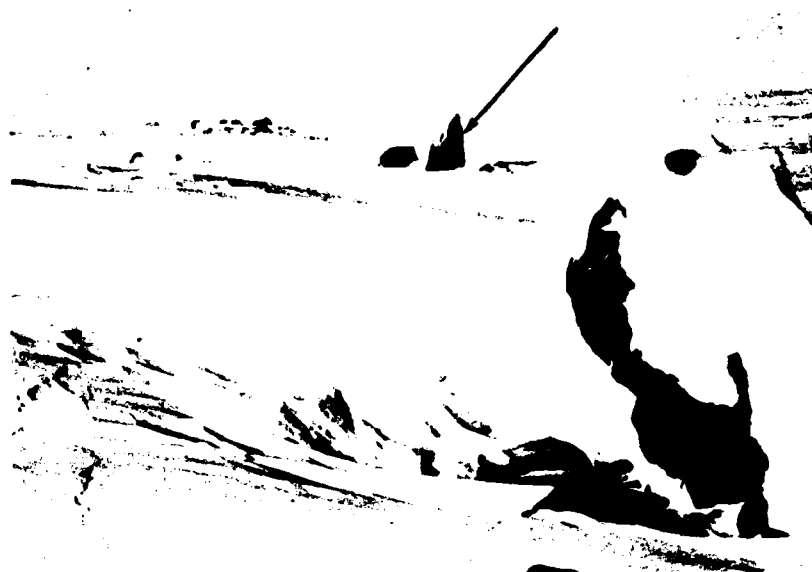
*Figure A12. View of west end of boulder rampart, April 1980.*

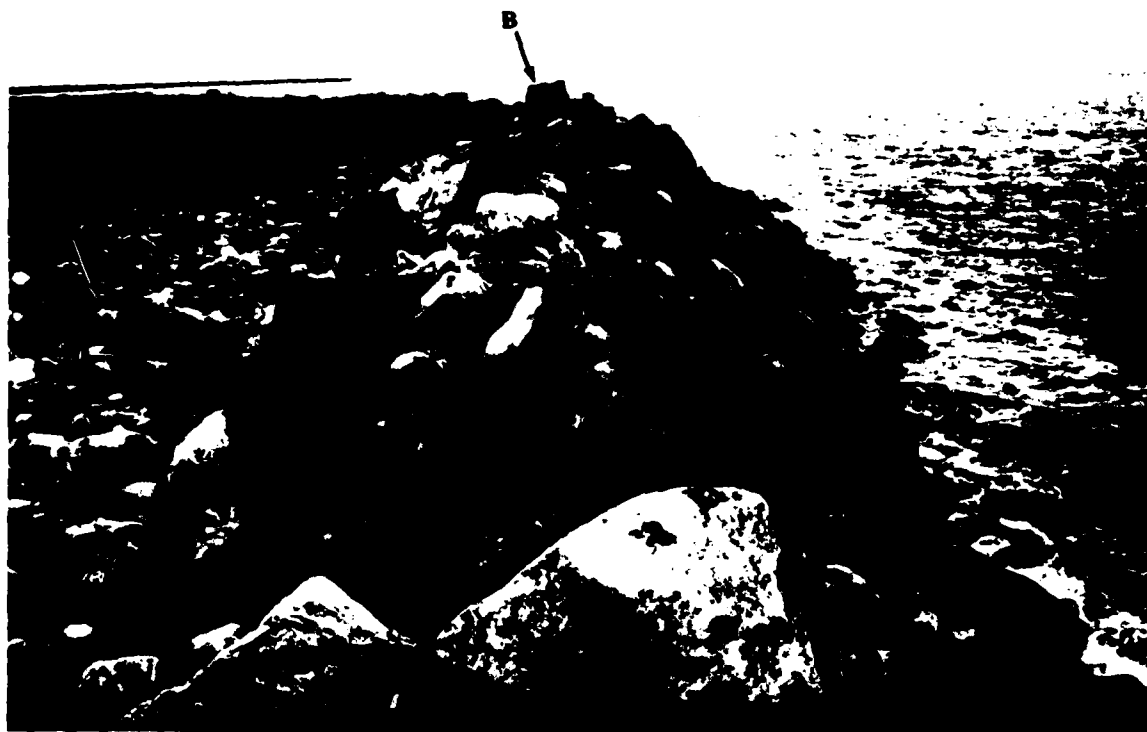
*Figure A14. View looking west along boulder rampart, summer 1979. (Photo courtesy P. Barnes.)*

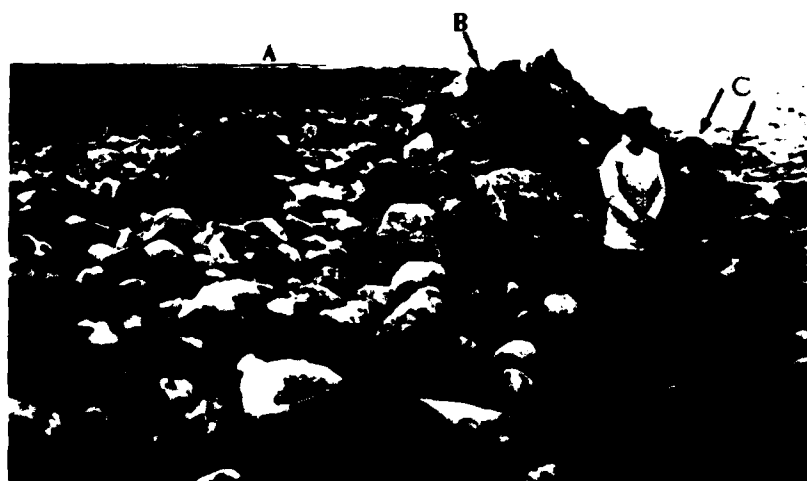
*Figure A15. View looking west along boulder rampart, summer 1981.*
